JOHN WAYNE MARINA – Property Condition Assessment

March 2019

Reid Middleton

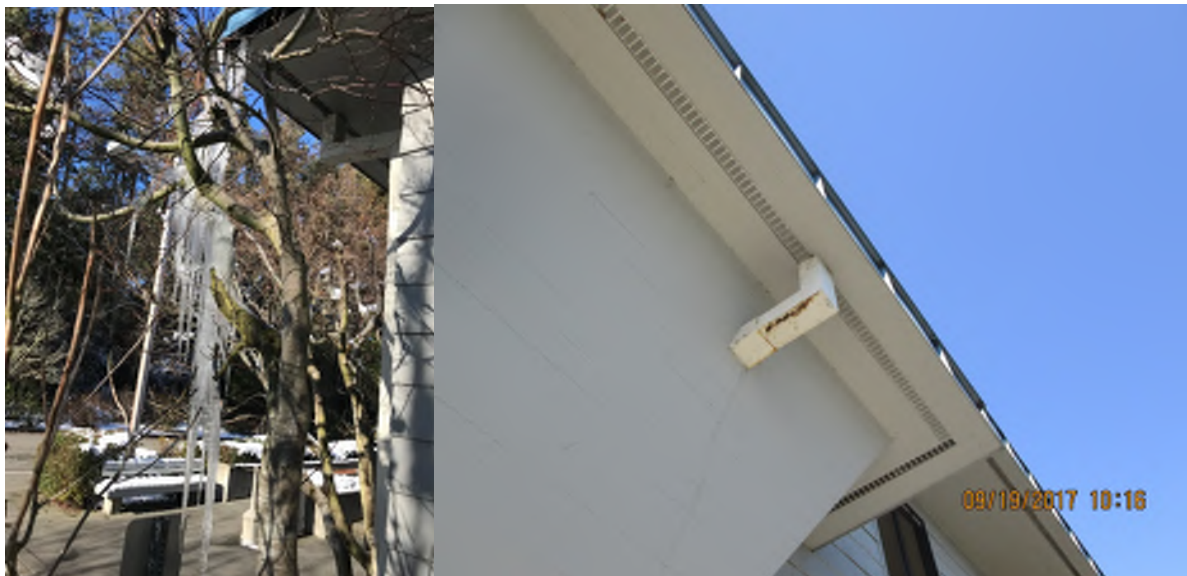
Figure 2. Administration Building – Icicle forming from Damaged Gutter Leakage.

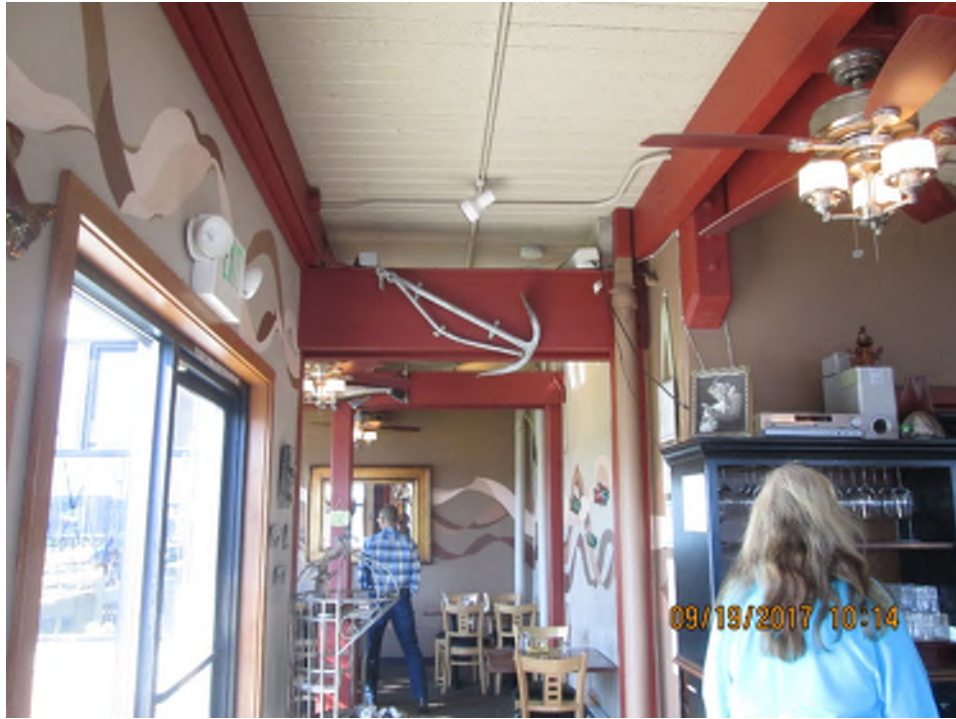
Figure 7. Restaurant – Interior
